Pre-Purchase Inspection Report

| Aircraft Make: | Kitfox | Aircraft registration: | C-FXCE |
| Aircraft Model: | Outback 5 | Aircraft S/N | 98080160 |

| Engine Type: | Rotax 912 ULS | Engine TTSN | Analog Hobbs: 384.3 Digital Hobbs: 482.9 |

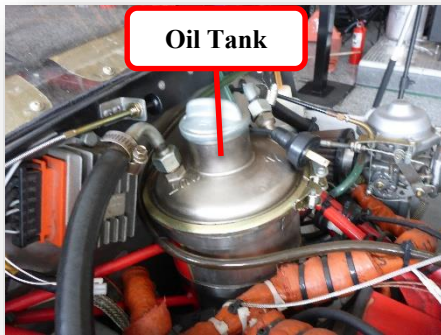
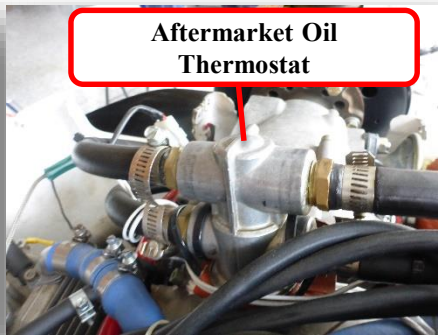
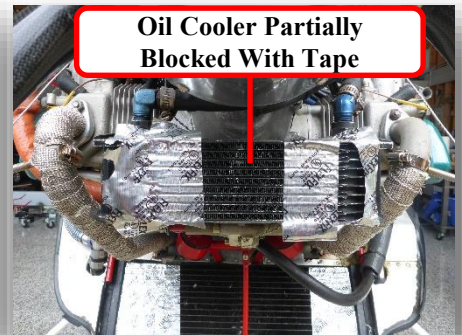
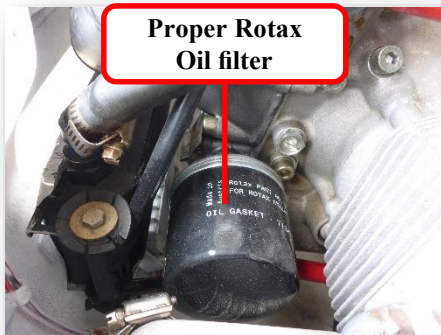
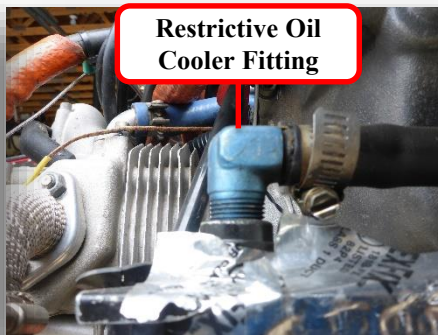
Lubrication System: The oil was found to be clean and in the middle of the flat portion of the dipstick (within limits). An aftermarket oil thermostat was incorporated into the oil system. The oil cooler was correctly installed and partially blocked with tape. Some operators who fly in colder climates often place tape over a portion of radiators to maintain operating temperatures. The inlet fitting of the oil cooler was not an optimal design or recommended due to its restrictive nature.

It's recommended to have the restrictive fitting changed to a more free-flowing type. The oil lines appeared to be in good overall condition with no leaks however, it's recommended to change the oil lines due to age.

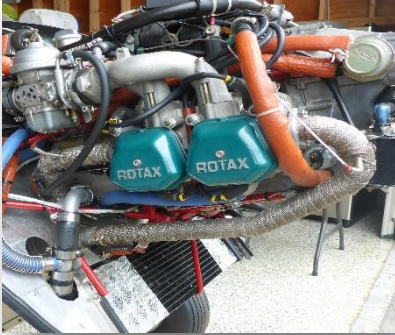
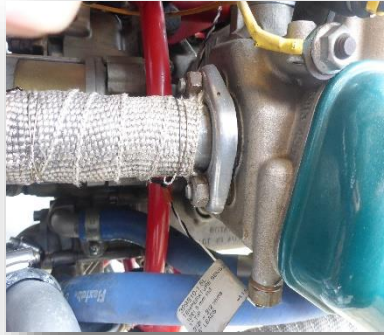
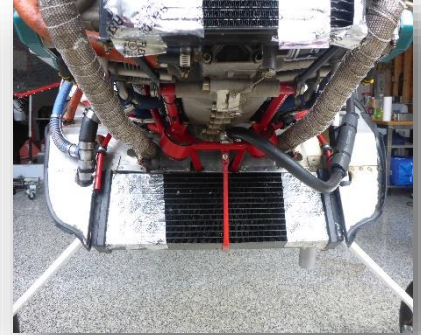
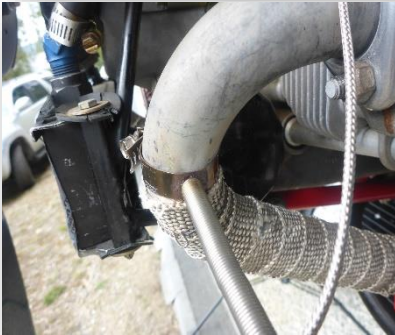
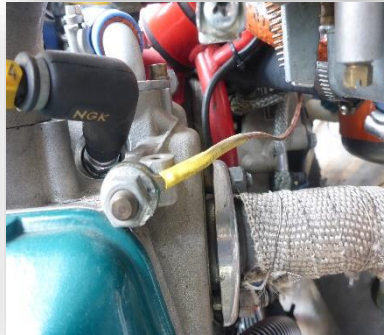
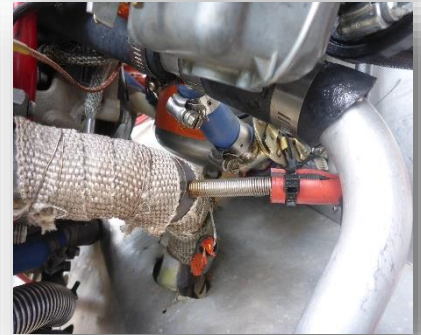
Exhaust system: The exhaust system was examined for condition, modifications, and conformity. The 4 exhaust pipes were mostly covered with a heat wrap and could not be fully inspected. The exhaust muffler appeared to be in good overall condition and properly secured.

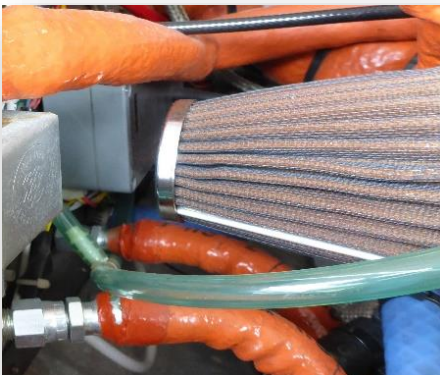
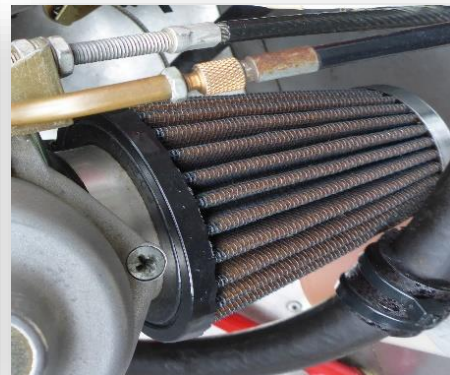
Air Filters: The air filters were examined for condition and proper type. Both air filters were K&N and appeared to be cleaned and properly oiled. No anomalies were seen with the air cleaners.

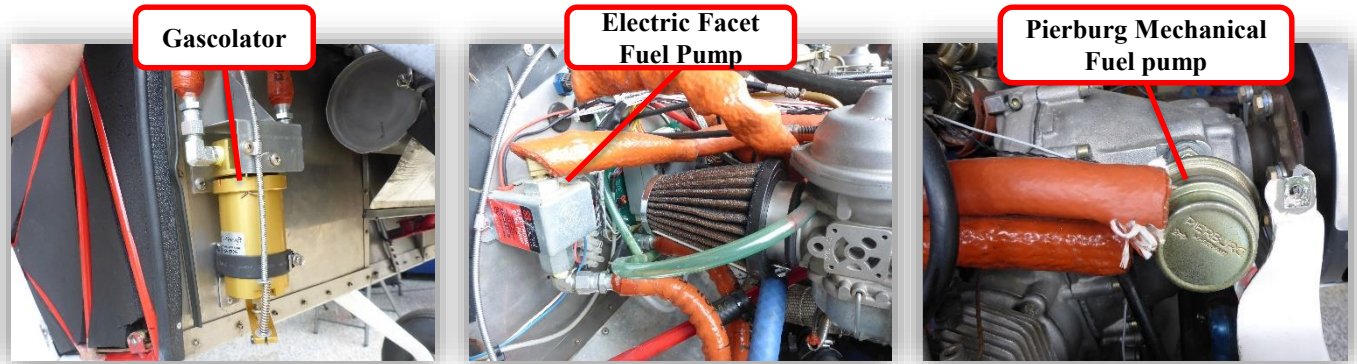
Fuel System: The fuel system was examined. Most of the fuel lines positioned forward of the firewall were covered in a protective fire sleeve and could not be fully examined. The portions of the fuel lines that were examined beyond the firewall were stiff and not pliable. When the fuel lines become hardened, they should be replaced.

Rotax sets a 5-year replacement limitation on all rubber components, including the mechanical fuel pump. The mechanical fuel pump installed on the engine was an "old Pierburg type" and well beyond 5 years old. The fuel system included a gascolator that appeared to be in good condition with easy access pull cable drain. A Facet electrical fuel pump was installed between the gascolator and the mechanical fuel pump. No anomalies were found with the electric fuel pump.

| Issues that should be addressed before flight | Issues that should be addressed during next maintenance interval |
|--|--|
| <p>Mechanical Fuel Pump should be changed to the new BDC Corona mechanical fuel pump</p> <p>All fuel and vent lines should be changed to good quality fuel lines</p> | <p>Investigate if all service bulletins have been complied with</p> <p>5 year rubber replacement should be done</p> <p>Swollen coolant hose should be replaced</p> <p>Oil pressure sensor should be changed</p> <p>Aftermarket bully hawk soft start system should be tested</p> <p>Carburetor floats should be weighed</p> <p>Oil cooler inlet fitting should be changed to a more free flowing fitting type</p> <p>Possible coolant leak should be investigated to determine if the water pump is leaking.</p> |

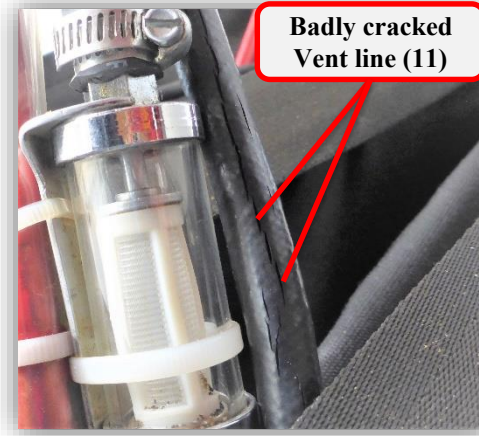
Fuel System (Continued) : The fuel vent line (11) from the header tank (4) to the wing tank (1) was badly cracked and when the fuel shut off valve (2) was turned on, fuel flowed from the wing tank to the header tank and back up the vent line. A substantial amount of fuel leaked out of the cracked header tank vent line.

During the inspection, the owner did replace the cracked vent line with a new fuel line, however, it is recommended that all fuel lines aft of the firewall are replaced with good quality fuel lines. Both fuel filters were examined and only a small amount of debris was found contained inside the fuel filters. Both fuel filters were mounted in a location that allowed for easy access and inspection. No anomalies found with the fuel filters.

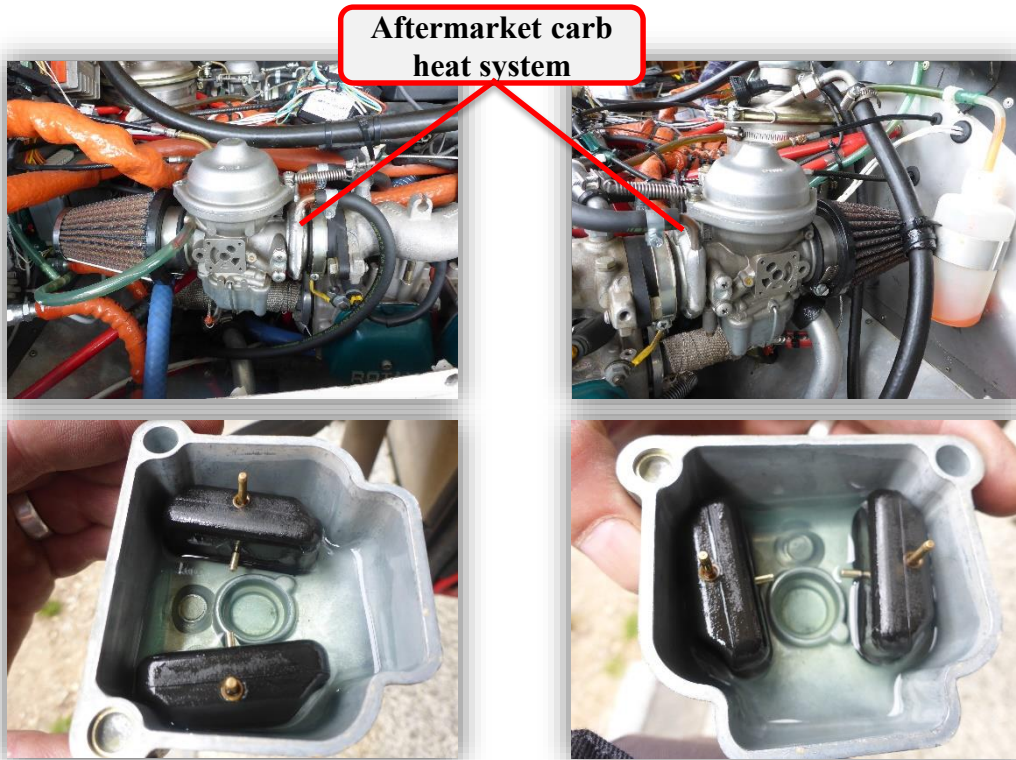
Carburetors: Both the 1/3 and 2/4 Carburetors were examined. Both carburetors had an aftermarket carb heat system installed that utilizes warm coolant from the coolant system. It is unknown how well this system works in carburetor icing conditions. The 1/3 Carburetor float bowl was removed and examined for any fuel contamination and float check. No anomalies were found with the 1/3 float bowls and the floats appeared to be in good overall condition. The floats were not weighed, however, the floats were placed in fuel and they appeared to be buoyant. A proper weight check should still be done on the floats to determine if they have absorbed fuel. The main jet was clear of any blockage and debris and the throttle linkage and choke operated normally and within their full travel range. No anomalies were seen with the 1/3 Carburetor.

The 2/4 Carburetor float bowl was removed and examined for any fuel contamination and float check. No anomalies were found with the 1/3 float bowls and the floats appeared to be in good overall condition. The floats were not weighed, however, the floats were placed in fuel and they appeared to be buoyant. A proper weight check should still be done on the floats to determine if they have absorbed fuel. The main jet was clear of any blockage and debris and the throttle linkage and choke operated normally and within their full travel range. No anomalies were seen with the 2/4 Carburetor.

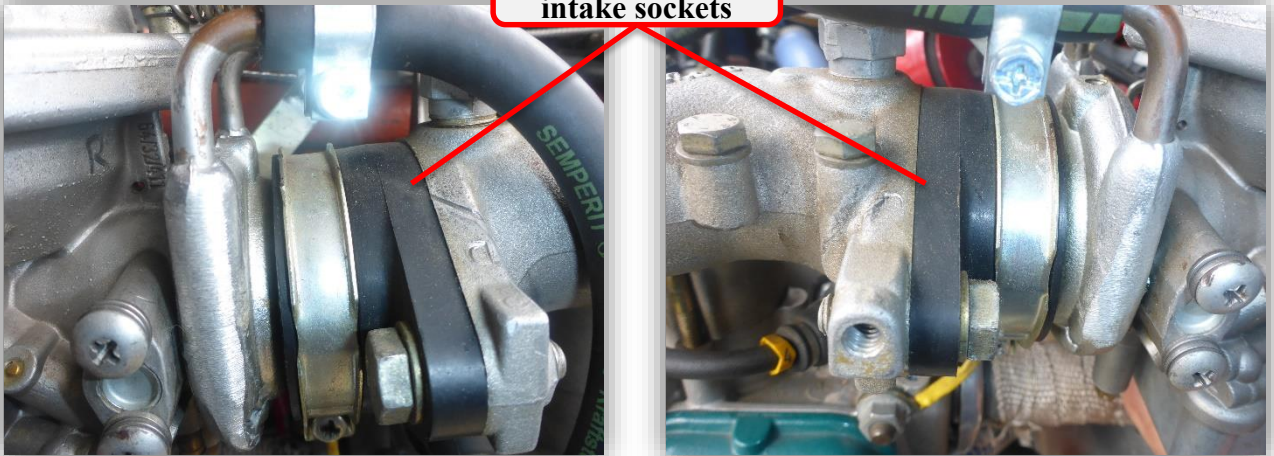
**Carburetor
intake sockets**

Carburetors (Continued): Both the 1/3 and 2/4 Carburetors intake sockets were examined for condition. It is unknown the age of the carburetor intake sockets however, they appeared to be in good overall condition with no evidence of cracking. The carburetor intake sockets have a life limit of 5 years as set out by Rotax and depending on when they were last changed, they may need to be replaced due to the age restriction. Due to the Kitfox engine mount design, the intake manifolds are swapped from one side to another for clearance. This places the carburetors further outboard than stock configuration and may cause more stress on the carburetor sockets. This can result in premature wear and issues when synchronizing the carburetors.

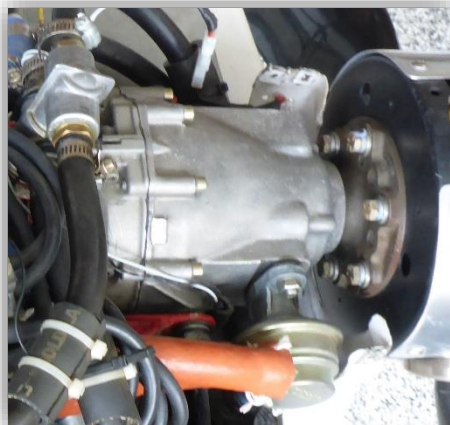
Reduction Gearbox: The reduction gearbox was inspected. the friction torque was checked on the reduction gearbox to determine its internal condition. The friction torque came to 413.4 in-lbs which is well within the limitations set out by Rotax. No issues were noted with the reduction gearbox.

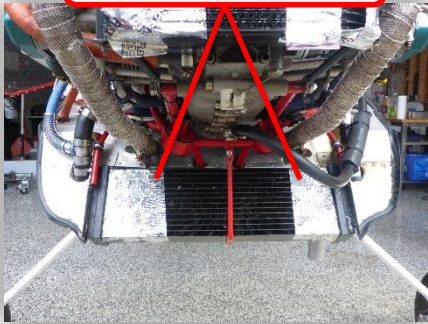
Coolant System: The coolant system was examined. The coolant radiator was correctly installed and partially blocked with tape (same as oil cooler) no anomalies were found with the coolant radiator. Some of the coolant lines were slightly swollen and should be replaced. The coolant lines that run from the cylinder heads to the water pump were upgraded to silicone and do not fall under the 5-year rubber replacement as set out by Rotax. All silicone lines appeared to be in good overall condition with no evidence of leakage.

Partially blocked coolant radiator

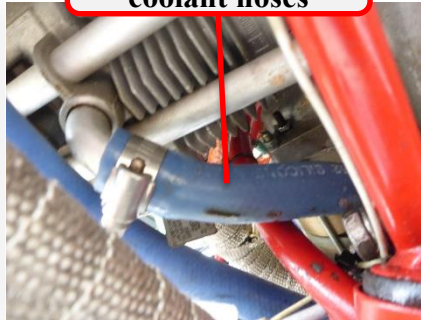
Updated cyclone coolant hoses

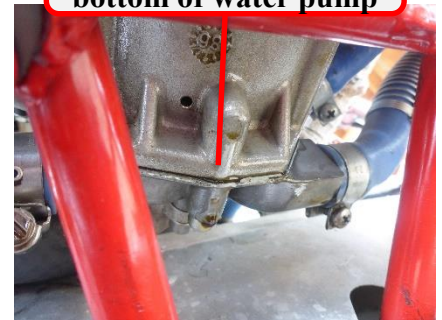
A small amount of coolant was found on the base of the water pump, however, it could not be determined if the water pump was leaking as there was no evidence of coolant on the bottom of the engine cowling. This coolant could have come from the service of the coolant system. The coolant expansion tank was full of what appeared to be the correct type of coolant and the overflow bottle was mounted correctly.

Slight coolant drip on bottom of water pump

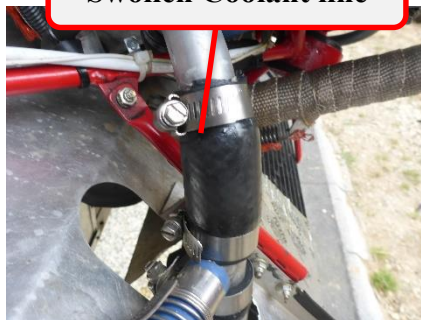
Swollen Coolant line

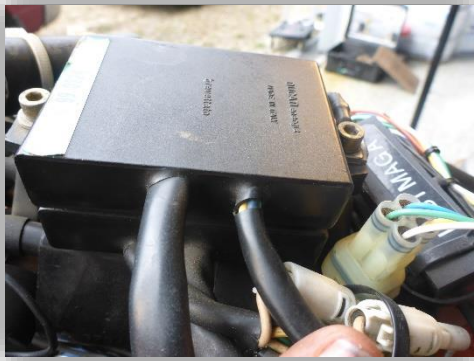
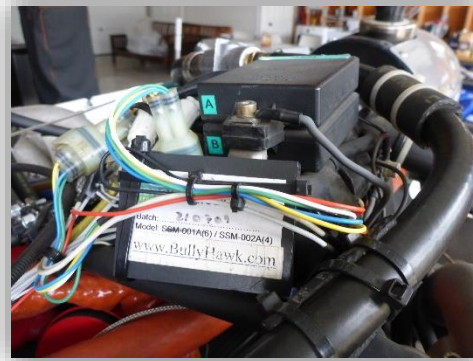
Ignition System: An aftermarket “Bully Hawk” soft start ignition module was installed on the engine. Some cracking of the protective shielding was seen on the ignition modules. This type of cracking is fairly superficial and may not affect the overall performance of the ignition system.

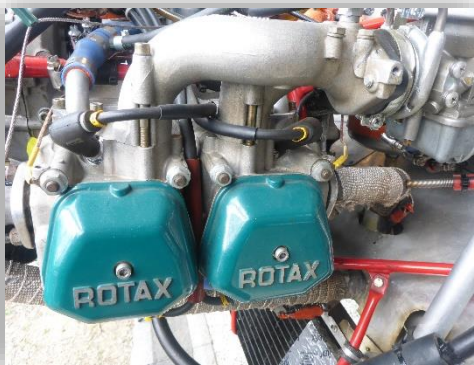
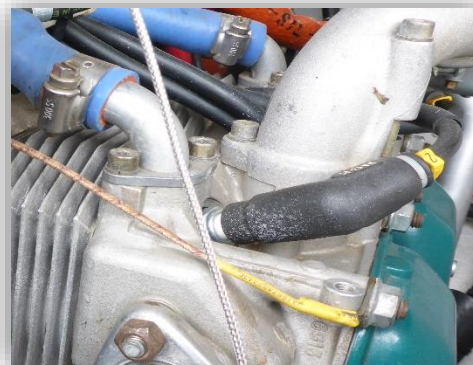
The ignition leads, spark plug boots and spark plugs were all examined for condition and proper type. No anomalies were seen with these items.
