Pre-Purchase Inspection Report

| Aircraft Make: | Kitfox | Aircraft registration: | C-FXCE |
| Aircraft Model: | Outback 5 | Aircraft S/N | 98080160 |

| Engine Type: | Rotax 912 ULS | Engine TTSN | Analog Hobbs: 384.3 Digital Hobbs: 482.9 |

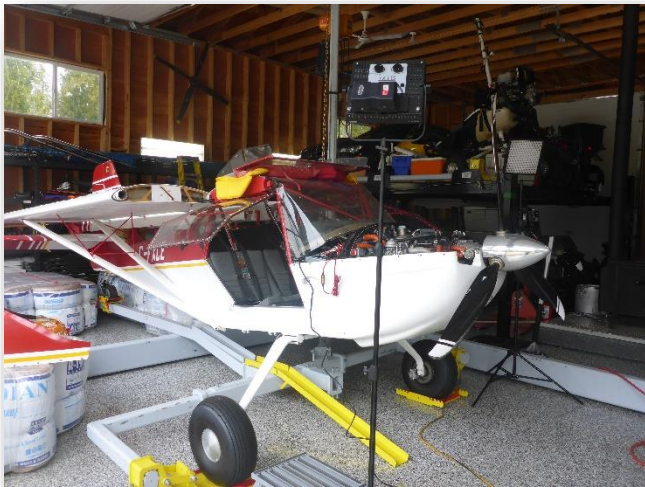
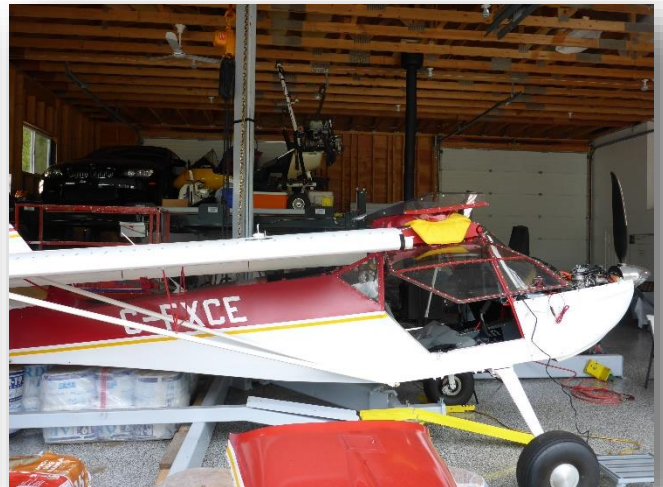
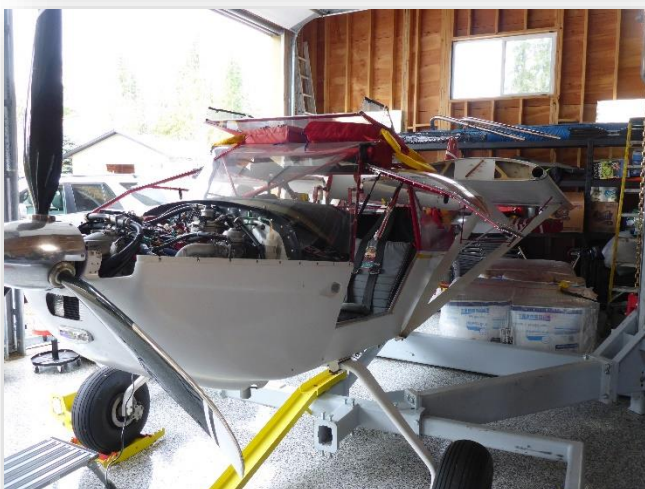
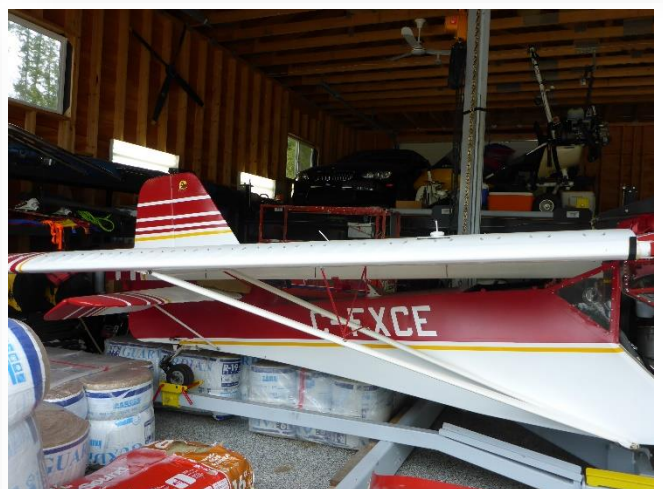
The aircraft was stored out of the elements and in the owner's hangar/garage on an aircraft lift, with its wings folded and the top engine cowl removed. A maintainer was connected to the battery.

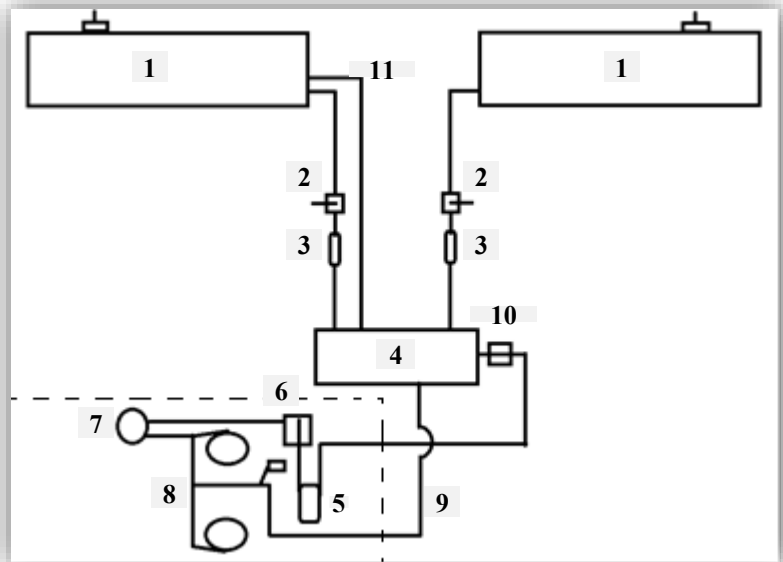
The fuel system design diagram:

- 1 Wing Tank
- 2 Fuel Shut off valves
- 3 Fuel Filters
- 4 Header Tank
- 5 Gascolator
- 6 Electric Fuel Pump
- 7 Mechanical Fuel Pump
- 8 Carburetors
- 9 Fuel Return Line
- 10 Checkvalve
- 11 Vent line

Fuel System (Continued) : The fuel vent line (11) from the header tank (4) to the wing tank (1) was badly cracked and when the fuel shut off valve (2) was turned on, fuel flowed from the wing tank to the header tank and back up the vent line. A substantial amount of fuel leaked out of the cracked header tank vent line.

During the inspection, the owner did replace the cracked vent line with a new fuel line, however, it is recommended that all fuel lines aft of the firewall are replaced with good quality fuel lines. Both fuel filters were examined and only a small amount of debris was found contained inside the fuel filters. Both fuel filters were mounted in a location that allowed for easy access and inspection. No anomalies found with the fuel filters.
